# ADVANCED COMPOSITE VERTICAL STABILIZER FOR DC-10 TRANSPORT AIRCRAFT

**SEVENTH QUARTERLY TECHNICAL PROGRESS REPORT  
25 SEPTEMBER 1978 THROUGH 31 DECEMBER 1978**

**DOUGLAS AIRCRAFT COMPANY**

ACEE-03-PR-9642

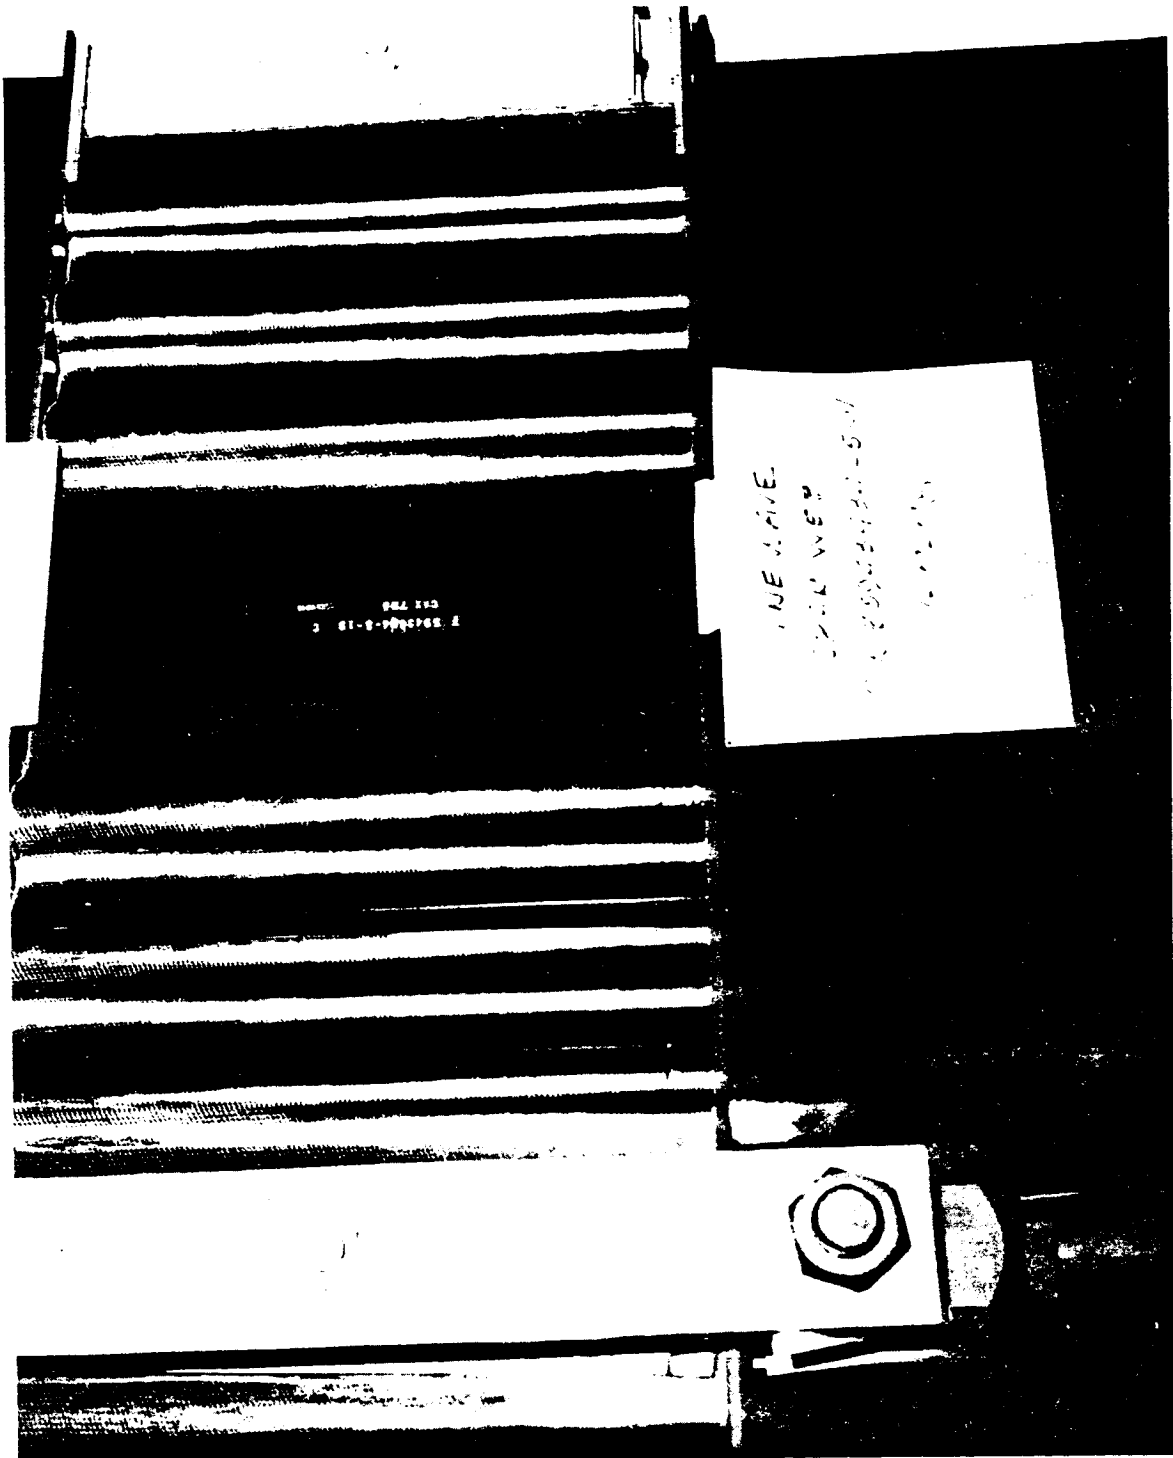
FIGURE 20. FLAT AREA IN Z5943434-501 SINE WAVE SPAR WEB

The Z5943434 sine-wave shear web component was redesigned and remade as a result of previous test component failure (see Reference 5). The redesign provided for two flat areas in the web for incorporation of 11.4 cm (4.5 inch) diameter access openings. The component included one access opening having flanged edges as shown in Figure 19. The other flat area in the specimen web was left blank to permit subsequent test evaluation of an unflanged cutout, see Figure 20.

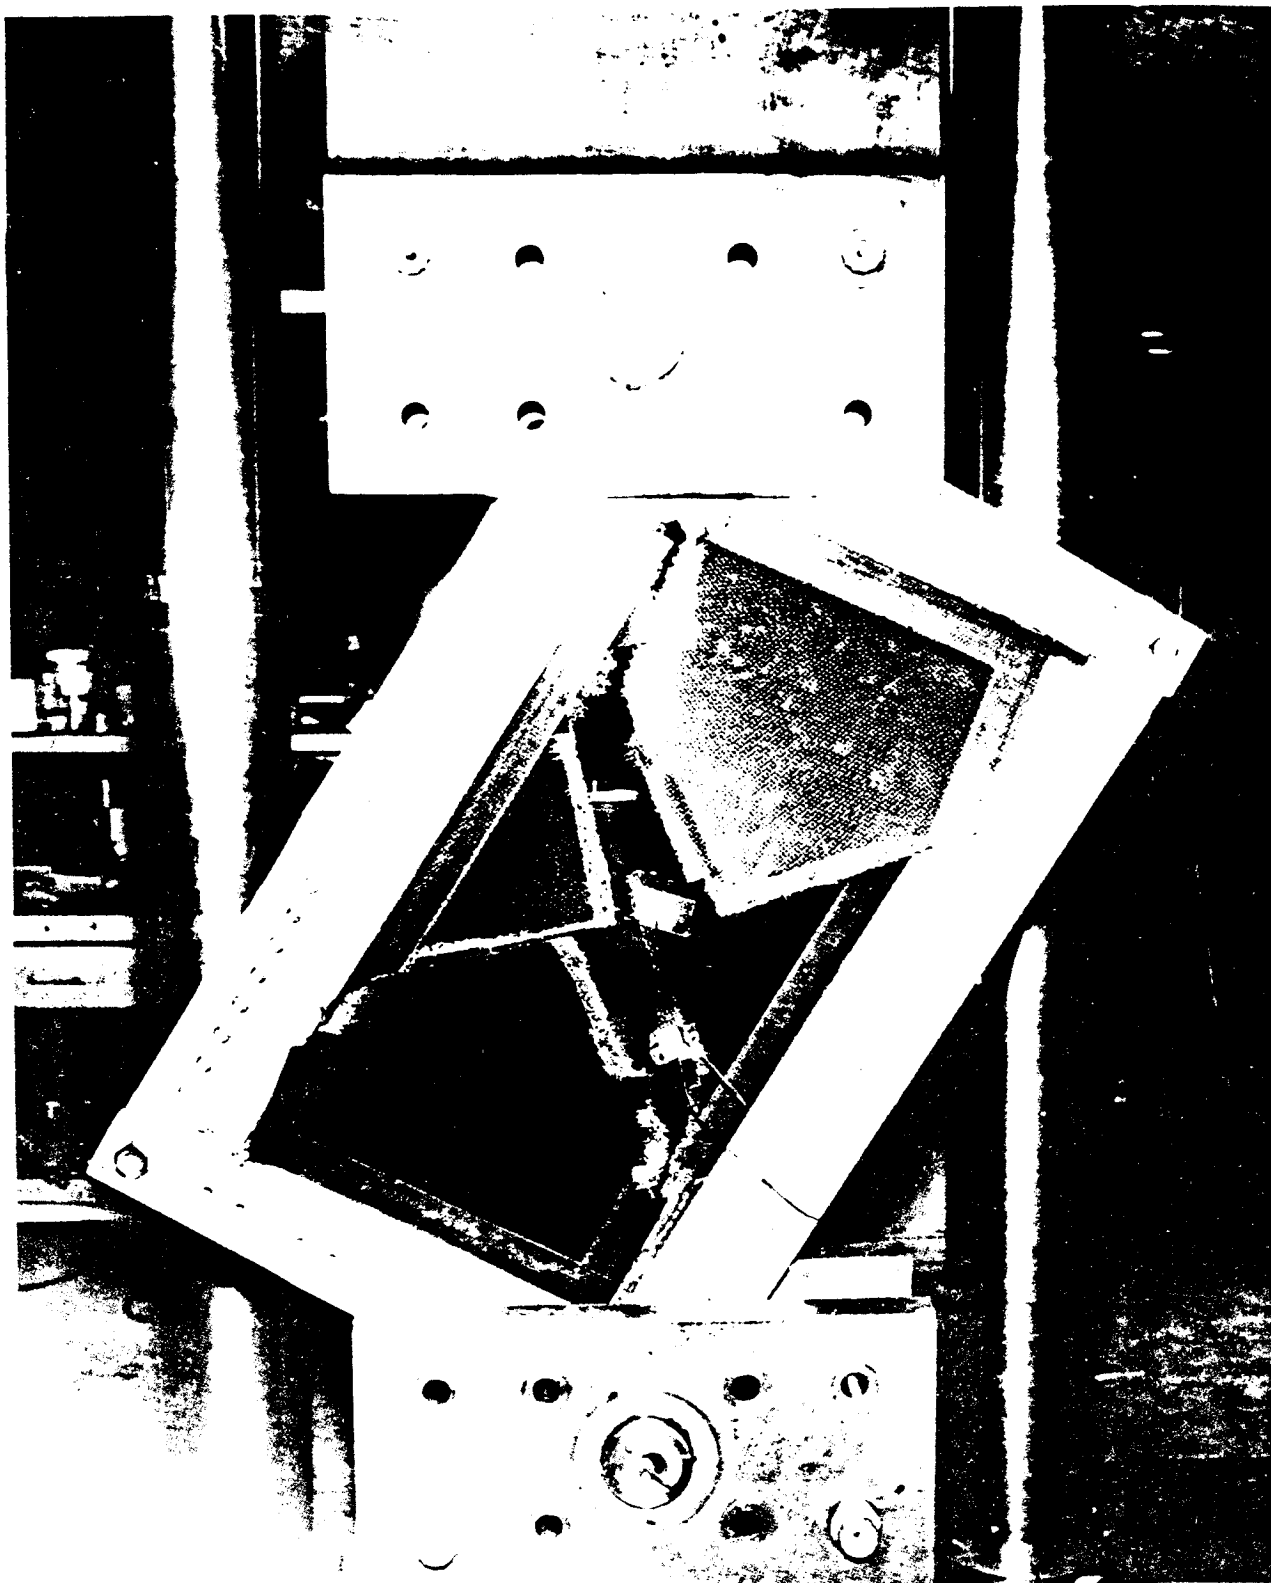
FIGURE 52. FAILURE OF Z5943428-501 DAMAGED SHEAR PANEL

any change or growth in size of the damaged area. The residual strengths were approximately 42 percent below the undamaged (and uncycled) panel at ambient temperature and 22 percent below the undamaged panel at 350°K. A typical failure mode for these panels is shown in Figure 52. All failures occurred through the damaged area.

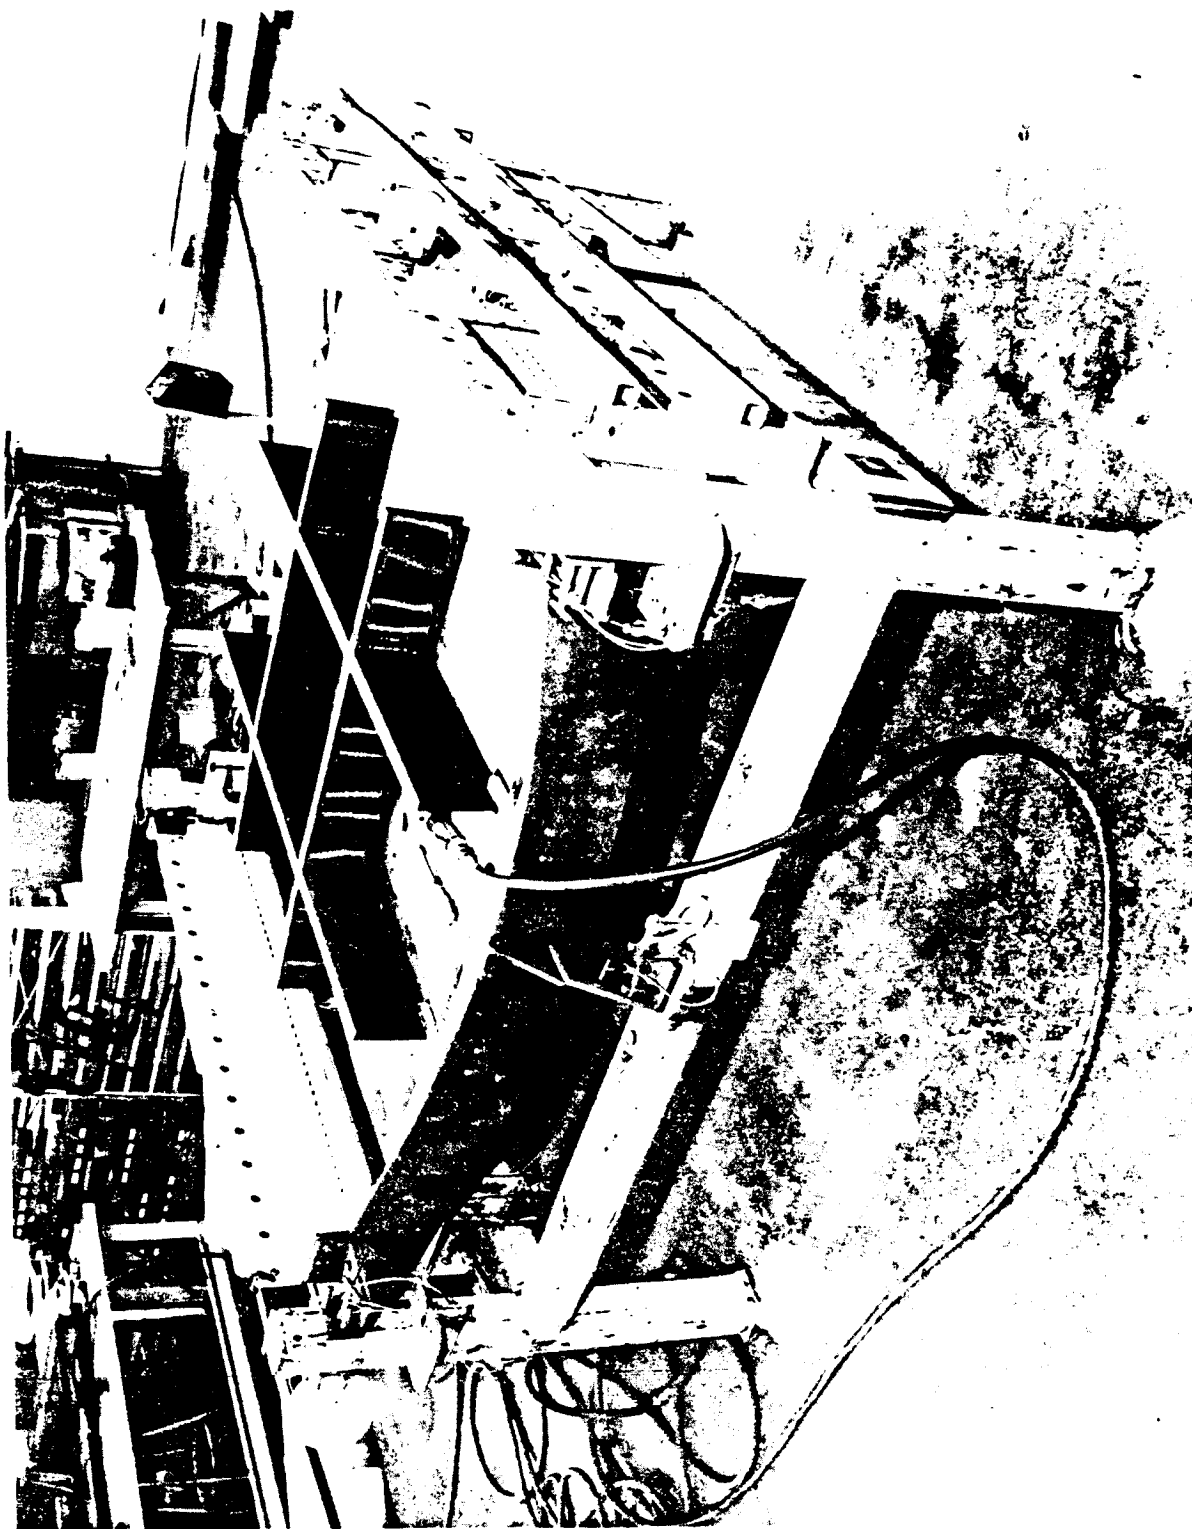
FIGURE 54. FINAL ASSEMBLY OF Z5943445 COMBINED LOAD TEST SPECIMEN

Assembly of the Z5943445-1 combined loads panel is in progress as shown in Figure 54. The cured skin panel, protected by peel plies on the outer surfaces, has been fit to the metal parts which will connect it to the test fixture. The sine-wave rib and spar-web elements have been trimmed to size and fit together. Subsequent operations will cocure and bond the rib and spar-web junctions using graphite-epoxy attach angles, and mechanically fasten the skin panel to the sine-wave substructure elements. Finally, the graphite-epoxy panel will be mechanically attached to the test frame.
